# Big Basin Water Company

## Governance Options Analysis

Local Agency Formation Commission  
of Santa Cruz County

Draft Version – March 6, 2024

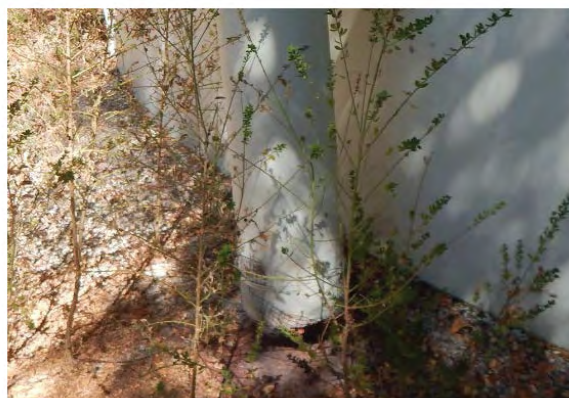
- a. The roof center vent is corroded and should be replaced.
- b. The roof access hatch does not include a seal. A seal or gasket must be provided to prevent the entry of insects into the tank. The Division recommends the roof access hatch is retrofitted with a sealing shoebox type hatch.
- c. The overflow line terminates about two inches above the ground surface right next to the tank as shown in the following picture. If the tank overflows, the water could destabilize the side of the tank. The Division recommends the overflow is diverted away from the tank and protected against animals with a screen or flapper valve.

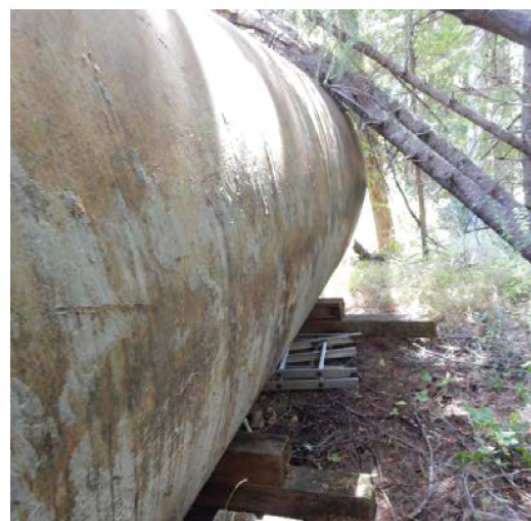
- a. The tank is a system equalization tank that stores about 10,000 gallons of water. The tank was not constructed according to drinking water standards and is in poor condition. The Division did not inspect the interior of the tank due to safety concerns and limited access. The tank exterior is corroded, tree branches have fallen on the tank, the tank does not include an adequate access hatch, and debris was observed around the tank. The cylindrical steel tank is installed horizontally on a wood foundation without any supports. The foundation is not adequate and is a safety risk for the water system and surrounding area. Big Basin WC must remove this tank from service no later than **March 20, 2019**. If a temporary tank will be installed, please present a plan to the Division by **February 20, 2019**.

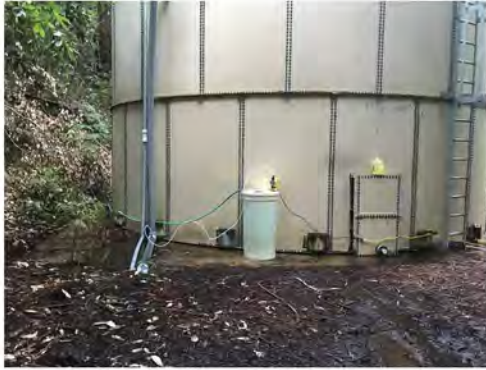
*Figure 1. Temporary Disinfectant Injection Configuration at Well # 4*

Proposed Corrective Action: In the short term, BBWC has installed a free chlorine injection system to improve the free chlorine residual in the distribution system. The electrical configuration of the chemical pump ensures that the pump only injects chlorine into the tank inlet piping when the groundwater well is operating (see Figure 1).

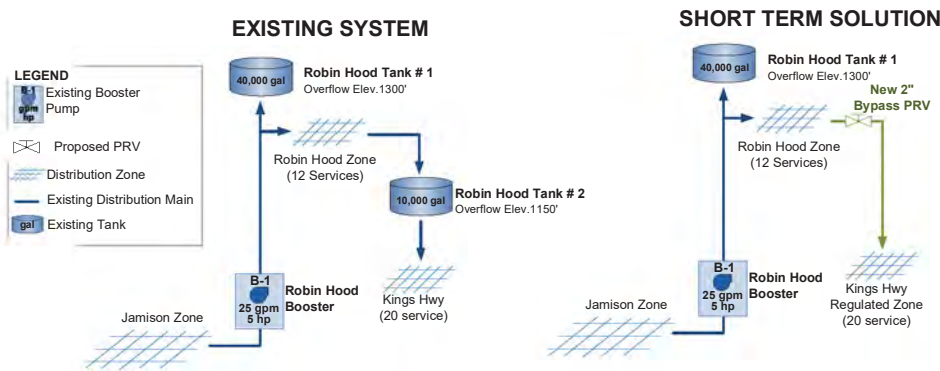
Figure 4. Proposed Corrective Action for Robin Hood Horizontal Tank (Tank #2) – Short Term

needed in order to bypass Robin Hood Tank #2. As a long-term solution, BBWC plans to construct a complete 6-inch regulating station at the reservoir site. The new regulating station will supply the existing Kings Highway zone service area. Once the construction of the regulating station is completed, the existing Robin Hood horizontal tank will be properly retired. The new regulating station will incorporate a Singer 6-inch S106-PR-C-SM dual-rolling diaphragm. If the primary chamber within the diaphragm fails, the secondary chamber will take over and regulate the downstream pressure at a desired pre-determined setpoint. The 6-inch valve can sustain a maximum flow rate of 1,800 gpm exceeding both fire flow requirements and maximum day demands in the zone.

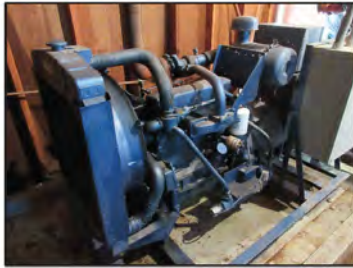
*Figure 9. Generator repaired and operational*

Proposed Corrective Actions: BBWC will replace both ruptured bladders inside the pressure tank with new Amtrol WX-456C bladder tanks. Existing piping and valving will be sandblasted and recoated. The existing generator has already been repaired and is now fully operational (see Figure 9). The existing roof and wood siding will also be replaced to protect the pumping equipment and ensure rodents do not enter the building.

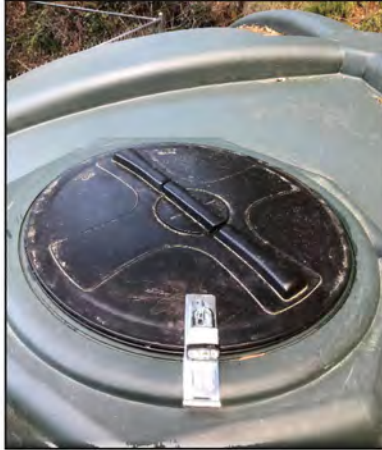
*Figure 10: Roof lock on China Grade Tank.*

Proposed Corrective Action: Install 145 feet of 6-ft high chain link fencing surrounding the tank site with one 12-ft entry gate. Construct approximately 1,000 sf of base rock or gravel roadway for safe access to the site. BBWC has installed a roof lock (see Figure 10).

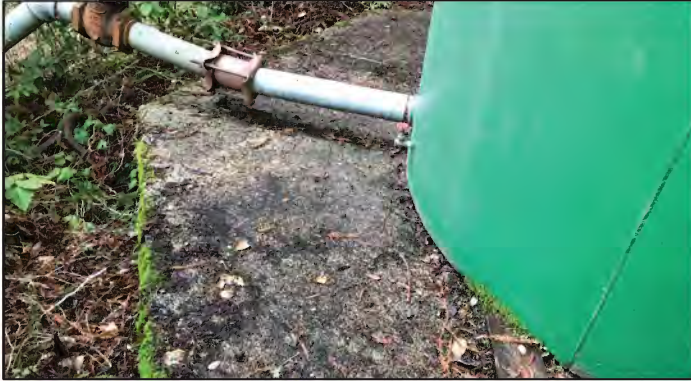
*Figure 12: Oberst Station existing foundation*

Proposed Corrective Action: BBWC will replace the Oberst tank with a 10,000 gallon polyethylene tank anchored to the existing foundation. BBWC will also install a fence surrounding the tank site with a 12-ft swing gate.

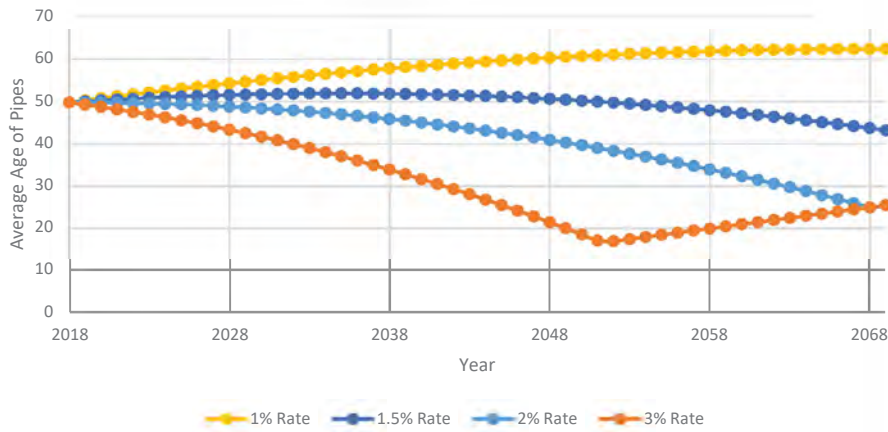
**Figure 14: Average age of pipelines under 1-3% replacement programs**

of pipes are replaced, thus reducing the average age and average risk of pipelines across the system. The analysis showed that a replacement rate of 1.5% would ensure that the average age of pipelines in the system does not grow over time, but decreases from about 50 years today to 43 years in 2069 (see Figure 14). Additionally, replacing at a 1.5% rate will prevent the pipeline failure rate from escalating to an unmanageable level. Instead, risk of pipeline failure will steadily decrease over time (see Figure 15).

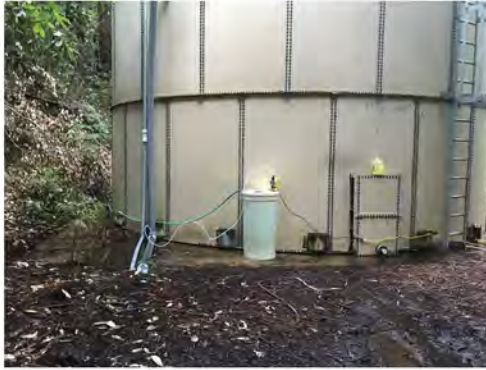
*Figure 1. Temporary Disinfectant Injection Configuration at Well # 4*

Identified Deficiency: Well 4 does not have a 50-foot sanitary seal and continually exerts a chlorine demand on system water that reduces the system chlorine residual. BBWC has been required to install chlorination at Well 4 since the 1994 permit from DDW but has not yet done so. BBWC must provide a plan for wellhead disinfection to DDW no later than March 10, 2019 and provide wellhead disinfection no later than May 20, 2019.

Proposed Corrective Action: In the short term, BBWC has installed a free chlorine injection system to improve the free chlorine residual in the distribution system. The electrical configuration of the chemical pump ensures that the pump only injects chlorine into the tank inlet piping when the groundwater well is operating (see Figure 1).

In the long term, a County permitted chemical storage and injection system will be installed. The system will include a 12.5% sodium hypochlorite solution. The solution will be stored with double containment consisting of a 55-gallon drum inside of a lockable polyethylene housing rated for the outdoors. This PE housing unit will be seated and anchored into a concrete foundation and will be located adjacent to the existing bolted steel tank. A peristaltic pump will inject free chlorine into the well discharge piping through a retractable injection assembly and using chemical piping and tubing to ensure double containment. The chemical pump will be activated whenever the groundwater well pump is running. Grab sampling from the tank outlet piping will confirm disinfectant levels entering the distribution system are adequate. Additional work will be performed to ensure that there is drainage away from the tank base.

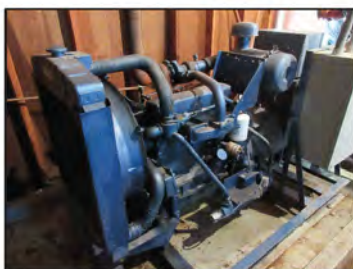
*Figure 9. Generator repaired and operational*

has been out of service and needs to be fixed since this pressure system is the sole source of water for the customers in this pressure zone.

Proposed Corrective Actions: BBWC will replace both ruptured bladders inside the pressure tank with new Amtrol WX-456C bladder tanks. Existing piping and valving will be sandblasted and recoated. The existing generator has already been repaired and is now fully operational (see Figure 9). The existing roof and wood siding will also be replaced to protect the pumping equipment and ensure rodents do not enter the building.

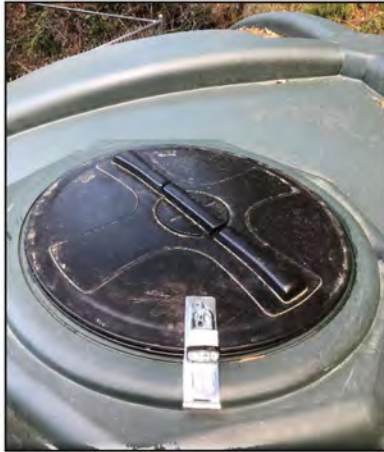
*Figure 10: Roof lock on China Grade Tank.*

Identified Deficiency: The tank site is not secured and DDW recommends a perimeter fence be installed. BBWC must ensure that there are no connections to the previously used redwood tank and install a roof lock.

Proposed Corrective Action: Install 145 feet of 6-ft high chain link fencing surrounding the tank site with one 12-ft entry gate. Construct approximately 1,000 sf of base rock or gravel roadway for safe access to the site. BBWC has installed a roof lock (see Figure 10).

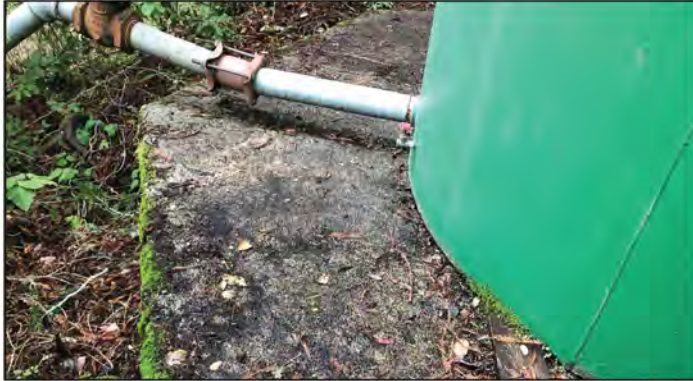
*Figure 12: Oberst Station existing foundation*

Identified Deficiency: The Oberst tank is an aged small steel tank. The interior and exterior coatings are severely corroded. Large rust nodules were observed attached to the interior tank wall. The corrosion presents a sanitary and structural risk. BBWC must provide a plan and schedule for replacement of this tank no later than May 10, 2019. The replacement plan must include NSF 61, AWWA, and Waterworks Standards compliance and a plan to construct a tank foundation and provide proper seismic supports.

Proposed Corrective Action: BBWC will replace the Oberst tank with a 10,000 gallon polyethylene tank anchored to the existing foundation. BBWC will also install a fence surrounding the tank site with a 12-ft swing gate.

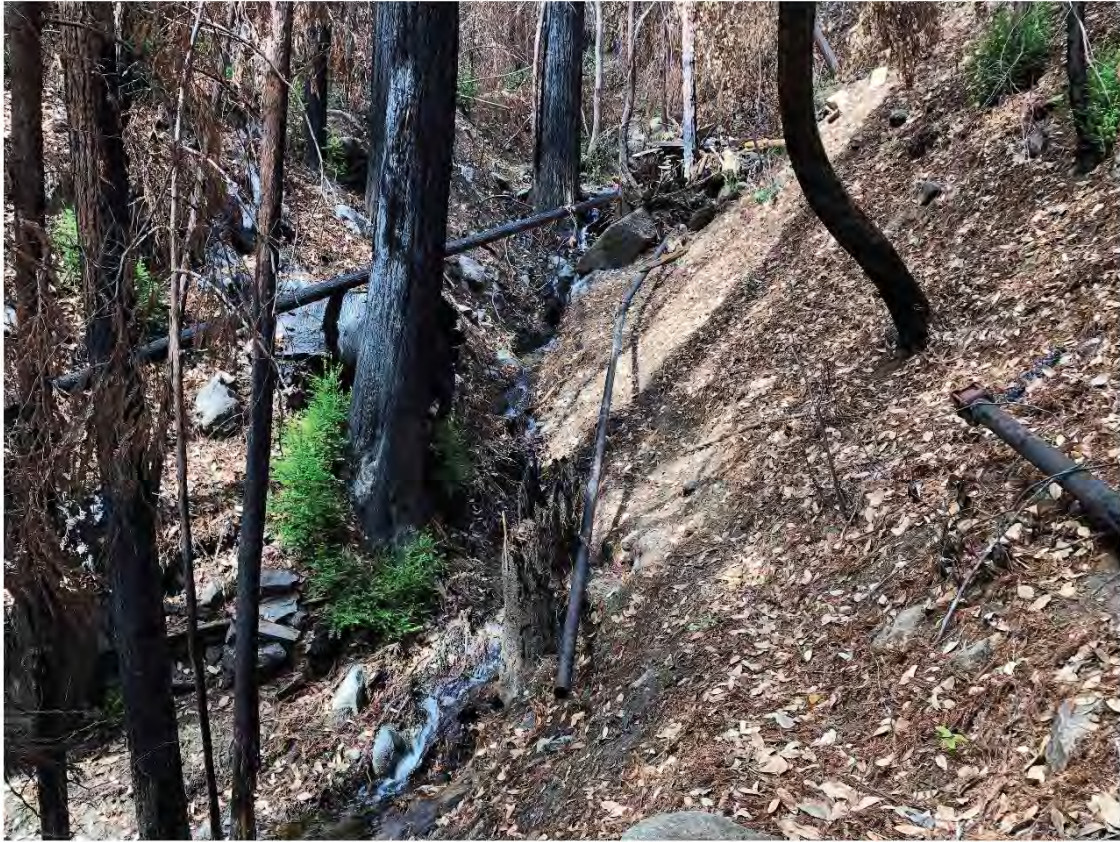
The primary change in the watershed discussed in this WSS update is the 2020 CZU Complex wildland fire that burned extensively through the BBWC service territory and caused extensive damage throughout each of BBWC's primary source watersheds. Notably, the Jamison SWTP was completely destroyed, leaving BBWC with only its groundwater sources available to provide source water capacity, primarily through Well No. 4.

*Typical fire damage in the watersheds.*

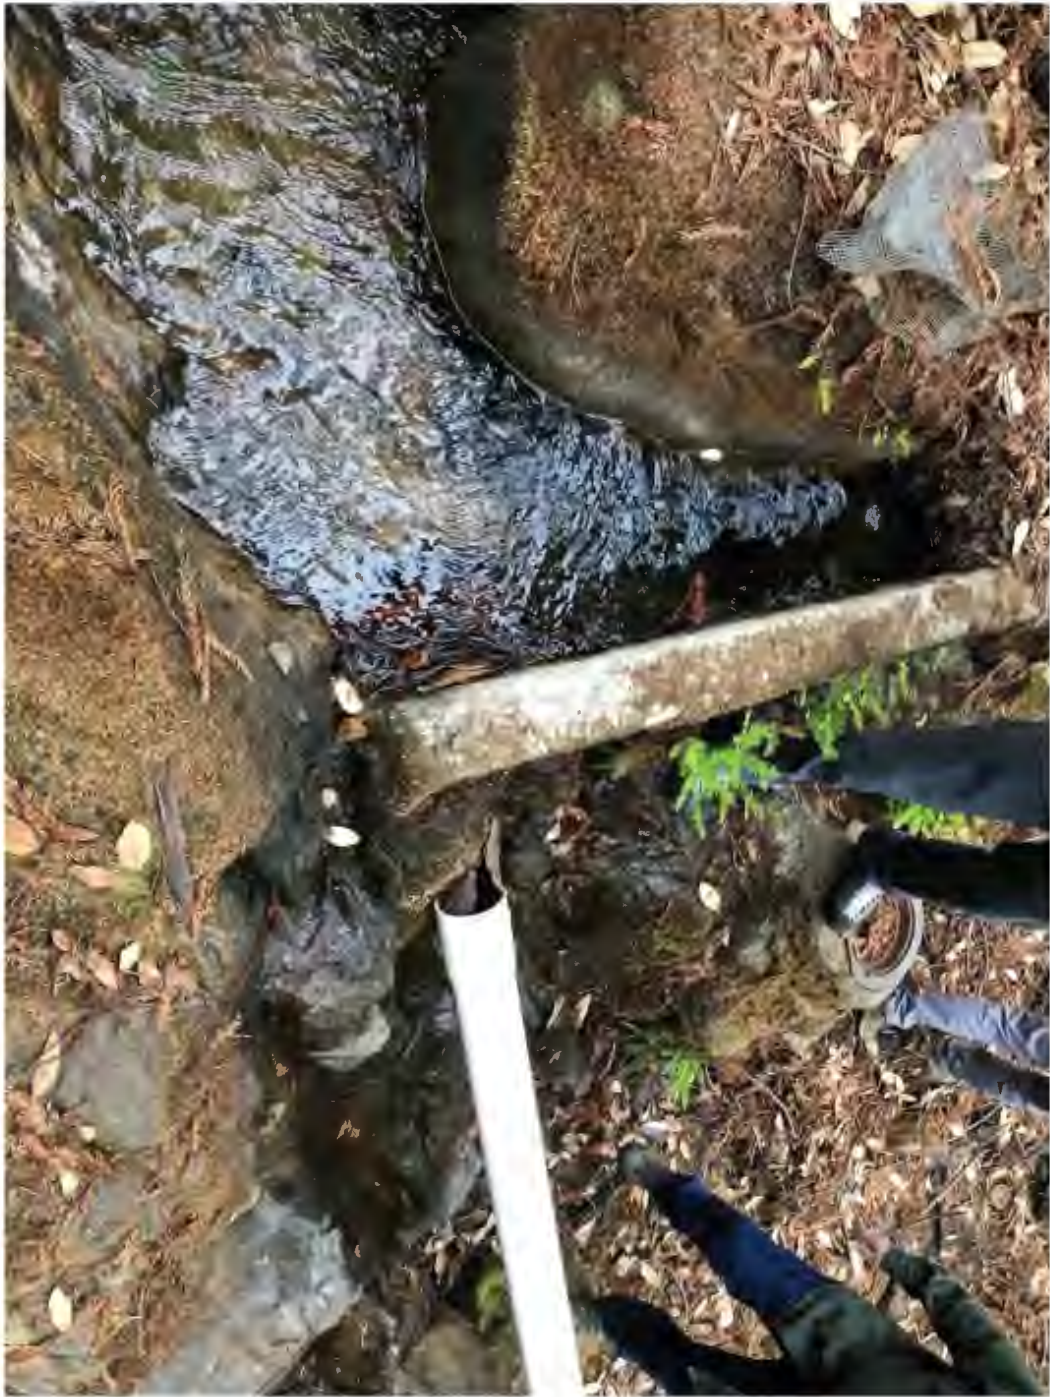
The diversions on Jamison Springs North and South have been repaired following the CZU fire. The diversion consists of a small concrete dam with a four inch steel pipe passing through it. The diversions provide some reduction of large debris and suspended solids from entering the raw water intake pipes. Each pipe has a manually cleaned screen that captures any large solids.

*Repaired South Creek raw water intake*

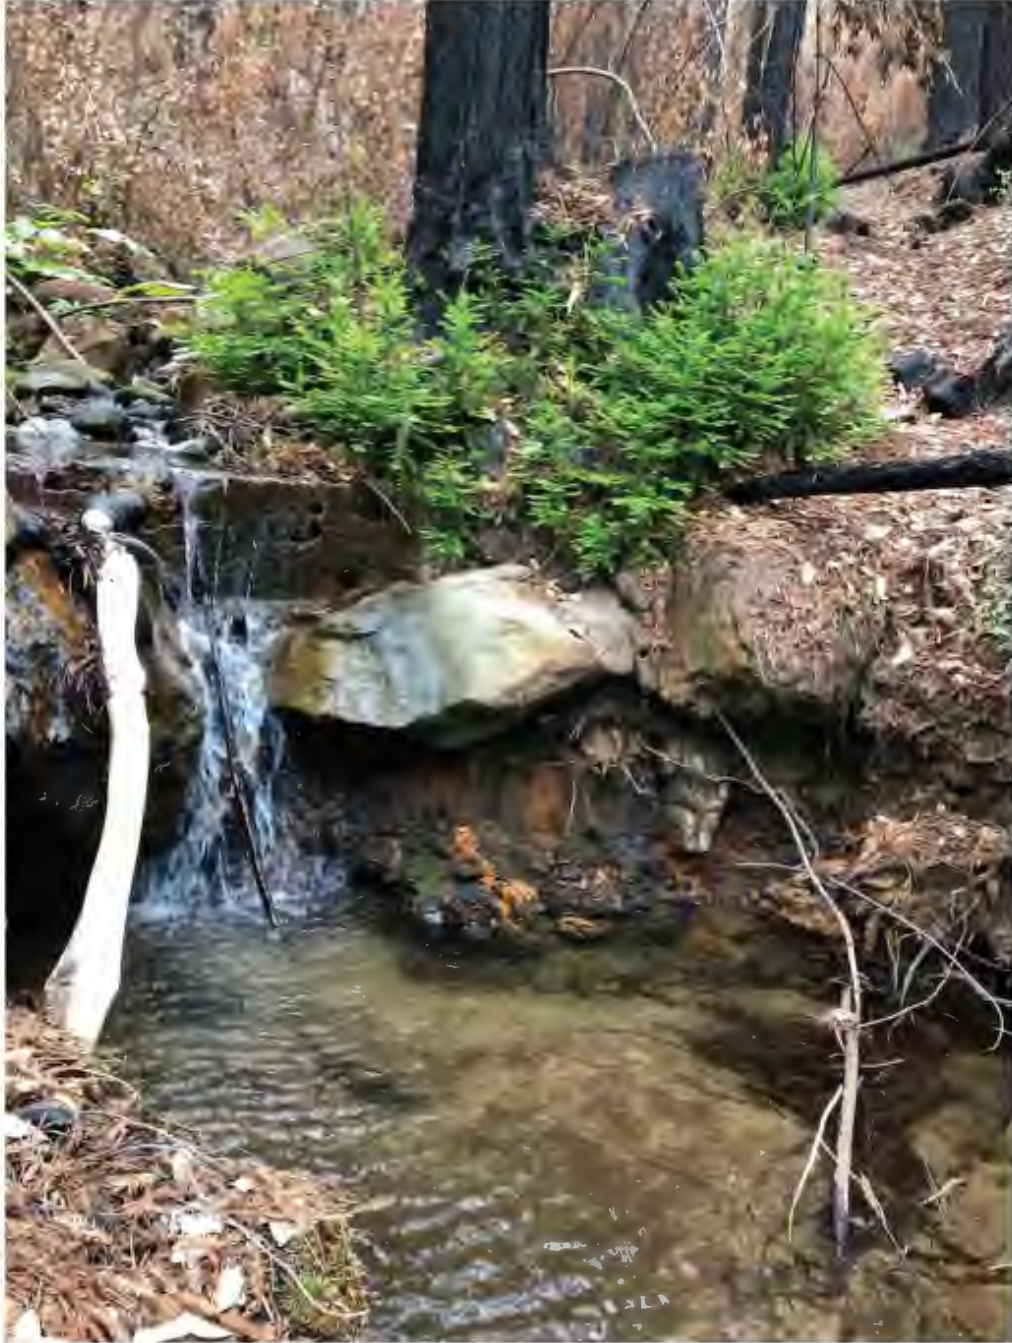
*North Creek intake prior to repairs completed in summer 2021.*

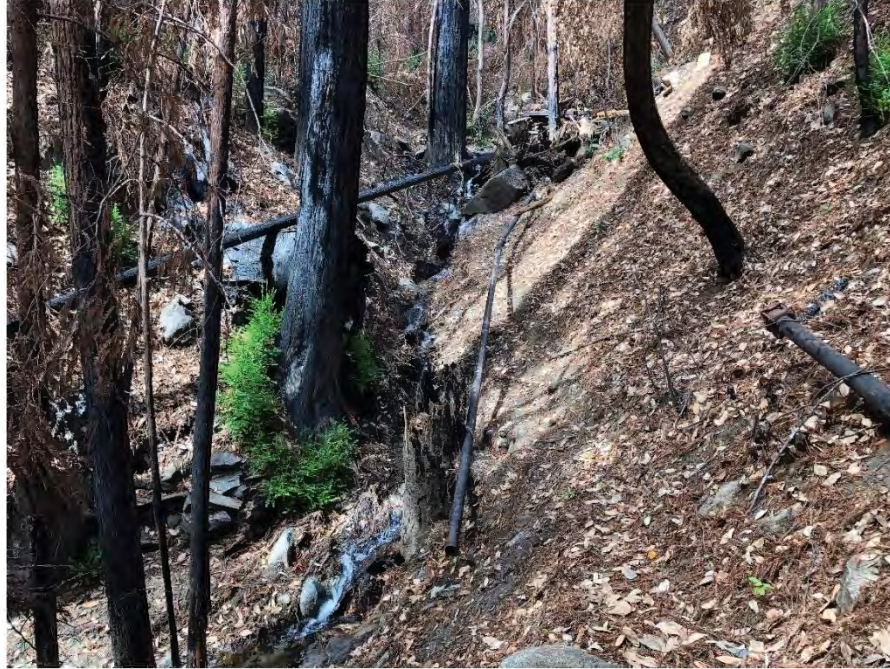
The Corvin Creek intake was completely destroyed by the CZU fire. BBWC plans to rebuild and use the Corvin Creek intake in the future.

*Corvin Creek intake not yet repaired.*

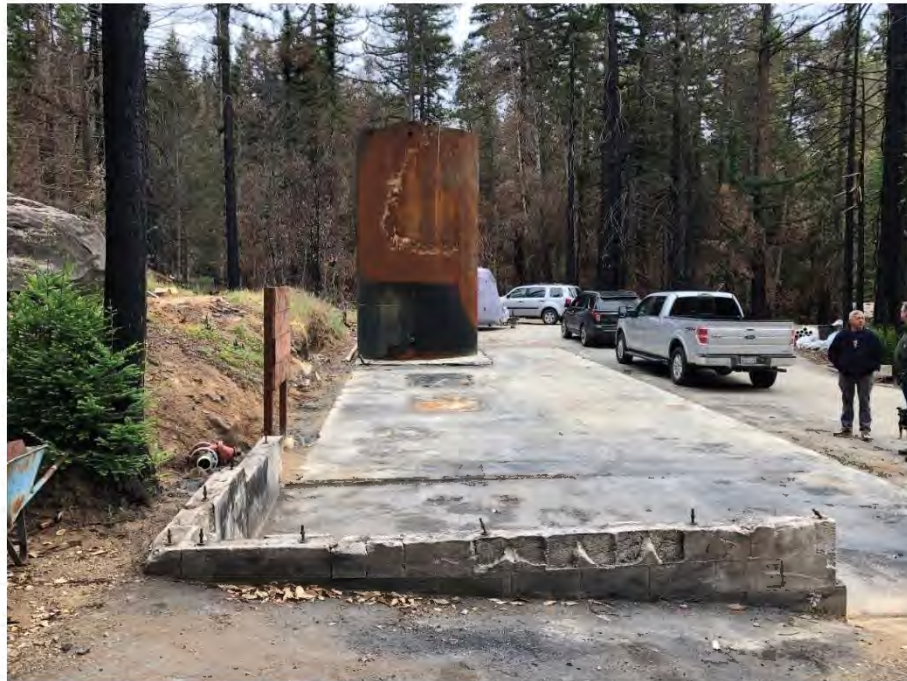
The Jamison Springs SWTP historically received water from Jamison Springs North and South and Corvin Creek. Raw water intakes captured water from both Jamison Springs North and South and conveyed it to a preliminary sedimentation tank. After sedimentation, the water was filtered, and chlorinated prior to storage in the 210,000 gallon storage tank. In 2020, the Jamison Springs SWTP was completely destroyed by the CZU wildfire.

*The remains of the Jamison SWTP after the 2020 CZU wildfire.*

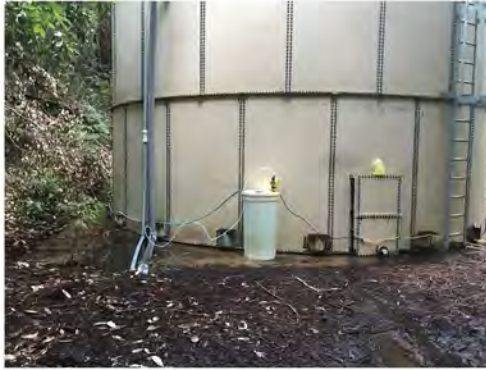
*Figure 1. Temporary Disinfectant Injection Configuration at Well # 4*

Identified Deficiency: Well 4 does not have a 50-foot sanitary seal and continually exerts a chlorine demand on system water that reduces the system chlorine residual. BBWC has been required to install chlorination at Well 4 since the 1994 permit from DDW but has not yet done so. BBWC must provide a plan for wellhead disinfection to DDW no later than March 10, 2019 and provide wellhead disinfection no later than May 20, 2019.

Proposed Corrective Action: In the short term, BBWC has installed a free chlorine injection system to improve the free chlorine residual in the distribution system. The electrical configuration of the chemical pump ensures that the pump only injects chlorine into the tank inlet piping when the groundwater well is operating (see Figure 1).

In the long term, a County permitted chemical storage and injection system will be installed. The system will include a 12.5% sodium hypochlorite solution. The solution will be stored with double containment consisting of a 55-gallon drum inside of a lockable polyethylene housing rated for the outdoors. This PE housing unit will be seated and anchored into a concrete foundation and will be located adjacent to the existing bolted steel tank. A peristaltic pump will inject free chlorine into the well discharge piping through a retractable injection assembly and using chemical piping and tubing to ensure double containment. The chemical pump will be activated whenever the groundwater well pump is running. Grab sampling from the tank outlet piping will confirm disinfectant levels entering the distribution system are adequate. Additional work will be performed to ensure that there is drainage away from the tank base.

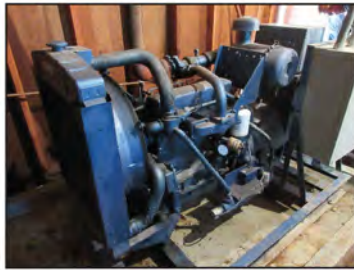
*Figure 9. Generator repaired and operational*

has been out of service and needs to be fixed since this pressure system is the sole source of water for the customers in this pressure zone.

Proposed Corrective Actions: BBWC will replace both ruptured bladders inside the pressure tank with new Amtrol WX-456C bladder tanks. Existing piping and valving will be sandblasted and recoated. The existing generator has already been repaired and is now fully operational (see Figure 9). The existing roof and wood siding will also be replaced to protect the pumping equipment and ensure rodents do not enter the building.

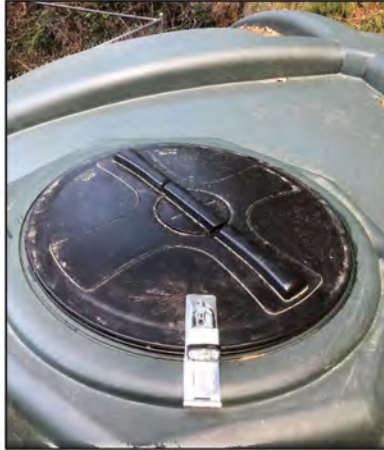
*Figure 10: Roof lock on China Grade Tank.*

Identified Deficiency: The tank site is not secured and DDW recommends a perimeter fence be installed. BBWC must ensure that there are no connections to the previously used redwood tank and install a roof lock.

Proposed Corrective Action: Install 145 feet of 6-ft high chain link fencing surrounding the tank site with one 12-ft entry gate. Construct approximately 1,000 sf of base rock or gravel roadway for safe access to the site. BBWC has installed a roof lock (see Figure 10).

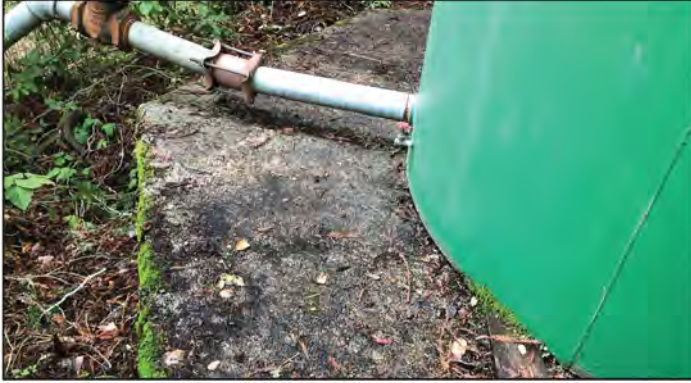
*Figure 12: Oberst Station existing foundation*

Identified Deficiency: The Oberst tank is an aged small steel tank. The interior and exterior coatings are severely corroded. Large rust nodules were observed attached to the interior tank wall. The corrosion presents a sanitary and structural risk. BBWC must provide a plan and schedule for replacement of this tank no later than May 10, 2019. The replacement plan must include NSF 61, AWWA, and Waterworks Standards compliance and a plan to construct a tank foundation and provide proper seismic supports.

Proposed Corrective Action: BBWC will replace the Oberst tank with a 10,000 gallon polyethylene tank anchored to the existing foundation. BBWC will also install a fence surrounding the tank site with a 12-ft swing gate.

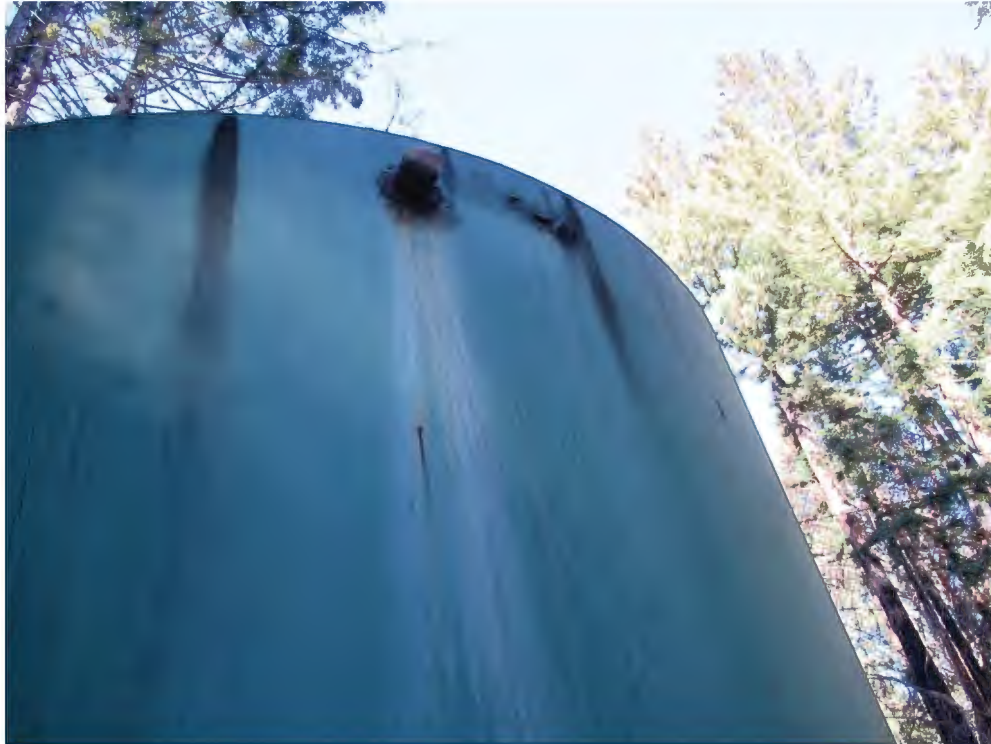
**Oberst Tank Photos**

Holes in the Tank Sidewall

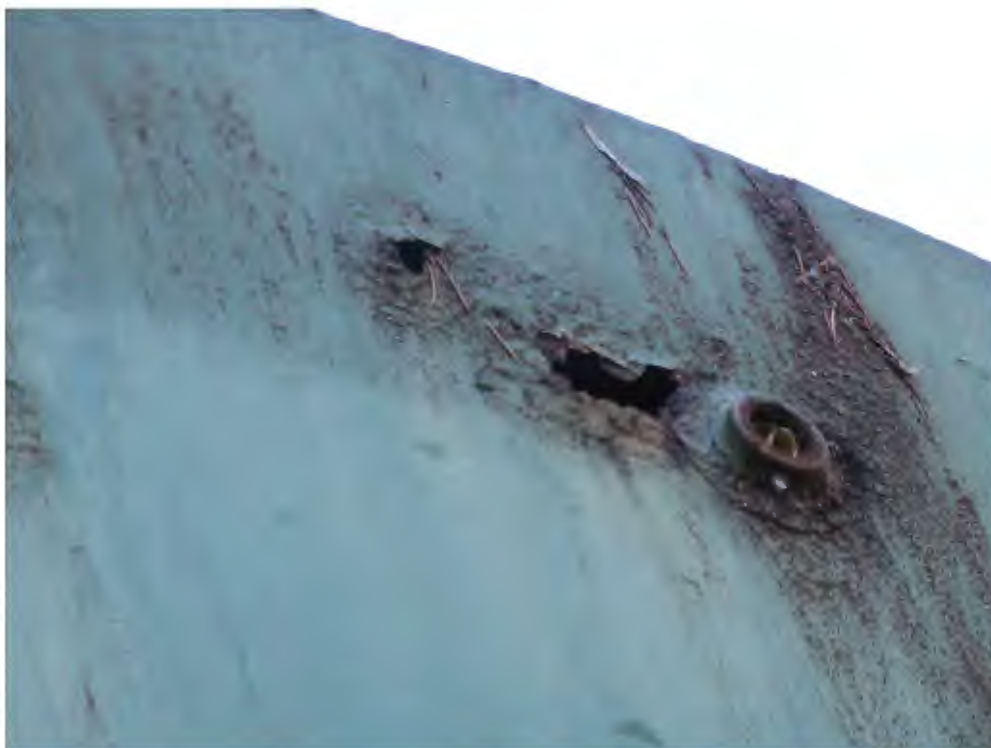
Enlarged Image of Tank Sidewall Holes

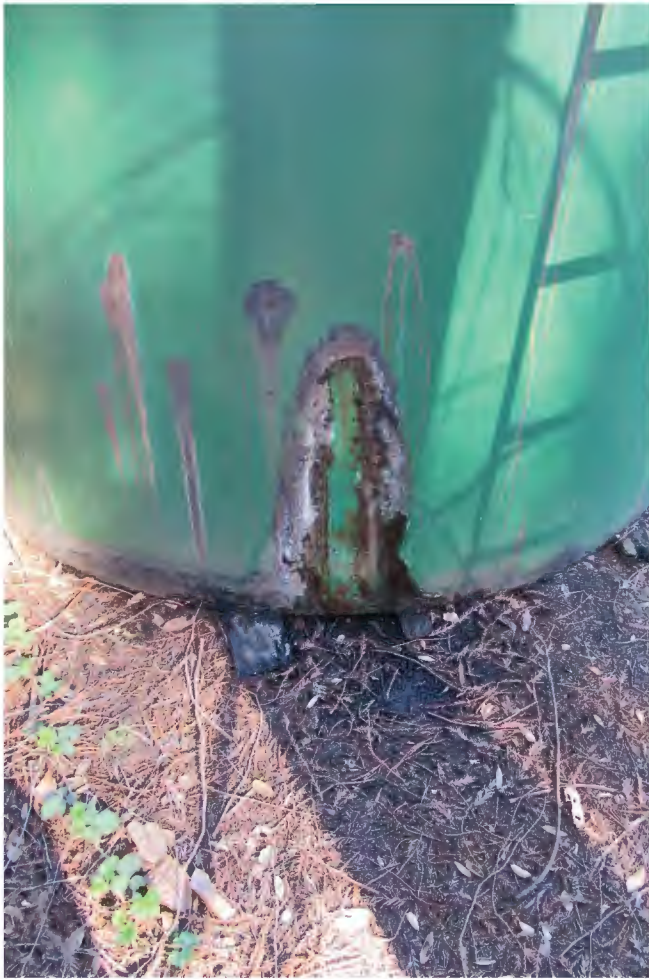
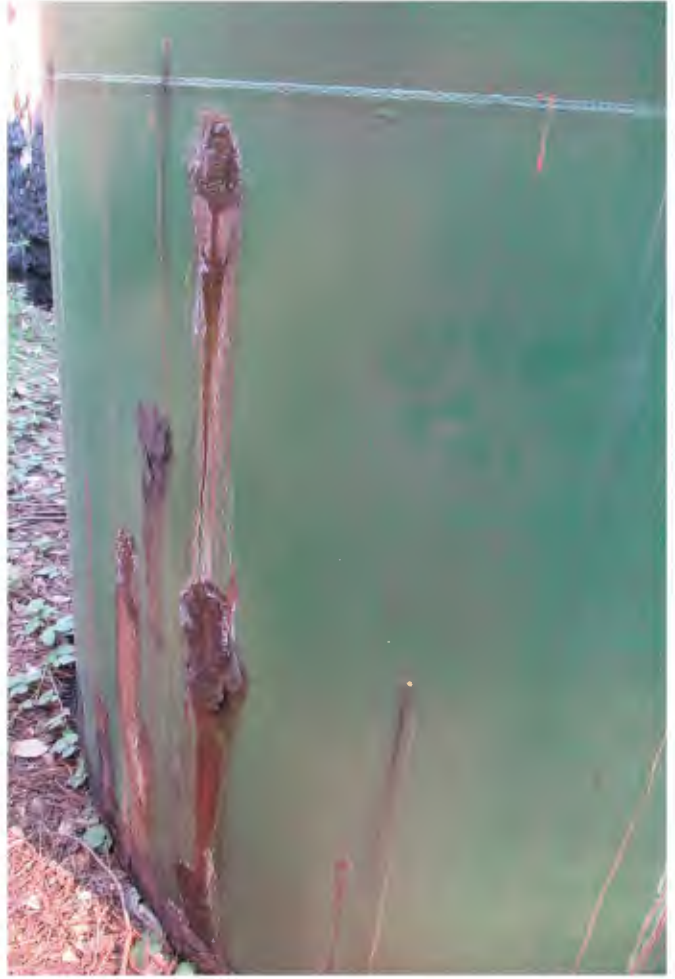
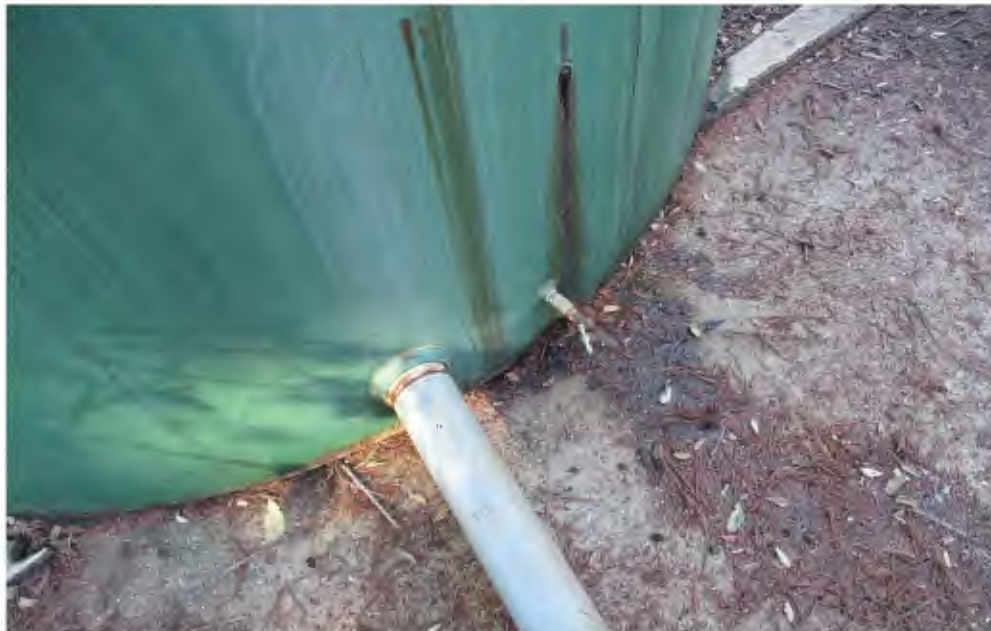
Corrosion and Leaks in the Tank Sidewall
