# **Big Basin Water Company**

## **Governance Options Analysis**

**Local Agency Formation Commission  
of Santa Cruz County**

Final Version – March 6, 2024

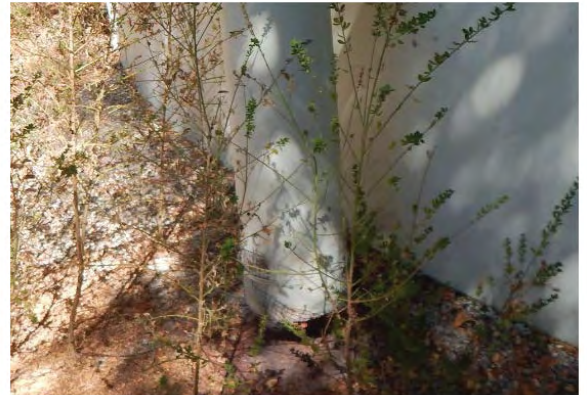
- a. The roof center vent is corroded and should be replaced.
- b. The roof access hatch does not include a seal. A seal or gasket must be provided to prevent the entry of insects into the tank. The Division recommends the roof access hatch is retrofitted with a sealing shoebox type hatch.
- c. The overflow line terminates about two inches above the ground surface right next to the tank as shown in the following picture. If the tank overflows, the water could destabilize the side of the tank. The Division recommends the overflow is diverted away from the tank and protected against animals with a screen or flapper valve.

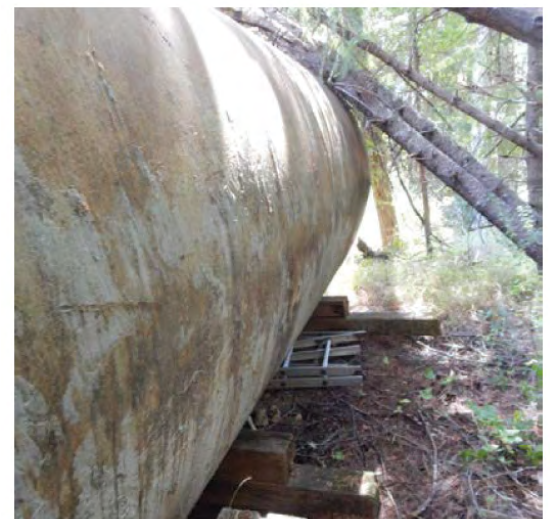
2. Robin Hood Tank (Bolted Steel):

- a. The tank is a system equalization tank that stores about 10,000 gallons of water. The tank was not constructed according to drinking water standards and is in poor condition. The Division did not inspect the interior of the tank due to safety concerns and limited access. The tank exterior is corroded, tree branches have fallen on the tank, the tank does not include an adequate access hatch, and debris was observed around the tank. The cylindrical steel tank is installed horizontally on a wood foundation without any supports. The foundation is not adequate and is a safety risk for the water system and surrounding area. Big Basin WC must remove this tank from service no later than **March 20, 2019**. If a temporary tank will be installed, please present a plan to the Division by **February 20, 2019**.

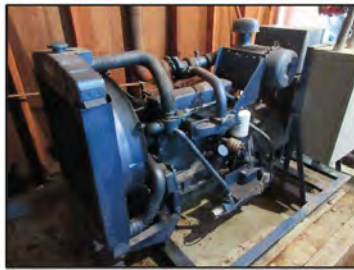
*Figure 9. Generator repaired and operational*

Proposed Corrective Actions: BBWC will replace both ruptured bladders inside the pressure tank with new Amtrol WX-456C bladder tanks. Existing piping and valving will be sandblasted and recoated. The existing generator has already been repaired and is now fully operational (see Figure 9). The existing roof and wood siding will also be replaced to protect the pumping equipment and ensure rodents do not enter the building.

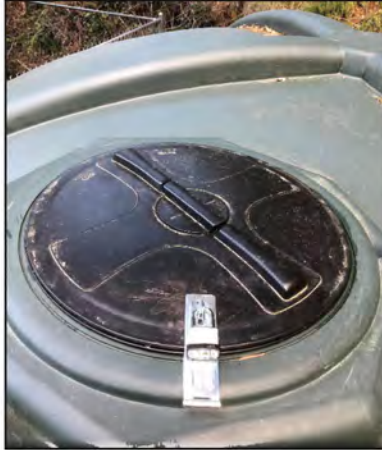
*Figure 10: Roof lock on China Grade Tank.*

Proposed Corrective Action: Install 145 feet of 6-ft high chain link fencing surrounding the tank site with one 12-ft entry gate. Construct approximately 1,000 sf of base rock or gravel roadway for safe access to the site. BBWC has installed a roof lock (see Figure 10).

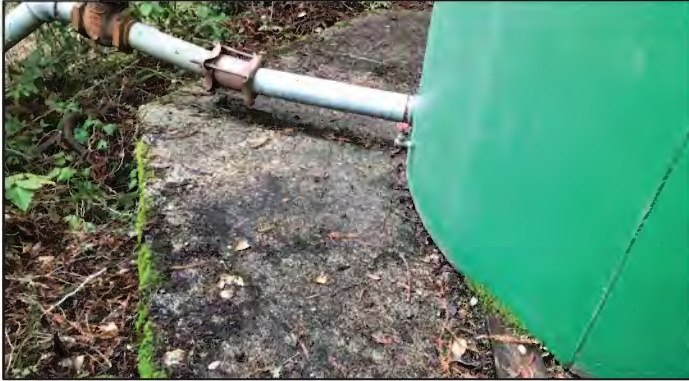
*Figure 12: Oberst Station existing foundation*

Proposed Corrective Action: BBWC will replace the Oberst tank with a 10,000 gallon polyethylene tank anchored to the existing foundation. BBWC will also install a fence surrounding the tank site with a 12-ft swing gate.

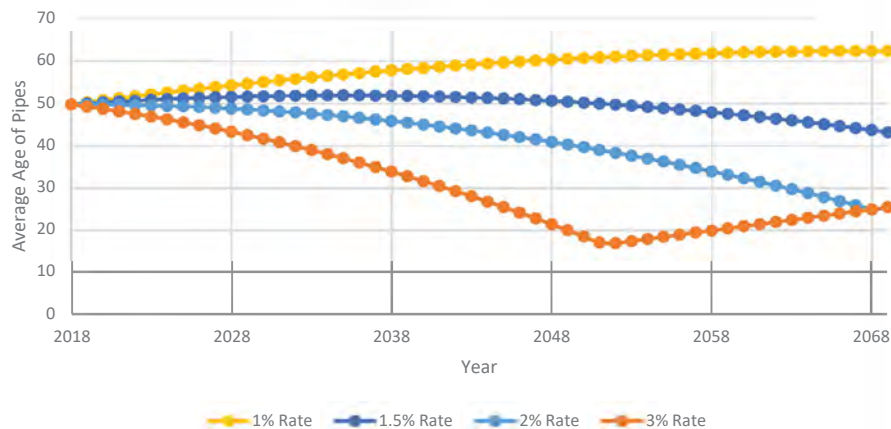
**Figure 14: Average age of pipelines under 1-3% replacement programs**

of pipes are replaced, thus reducing the average age and average risk of pipelines across the system. The analysis showed that a replacement rate of 1.5% would ensure that the average age of pipelines in the system does not grow over time, but decreases from about 50 years today to 43 years in 2069 (see Figure 14). Additionally, replacing at a 1.5% rate will prevent the pipeline failure rate from escalating to an unmanageable level. Instead, risk of pipeline failure will steadily decrease over time (see Figure 15).

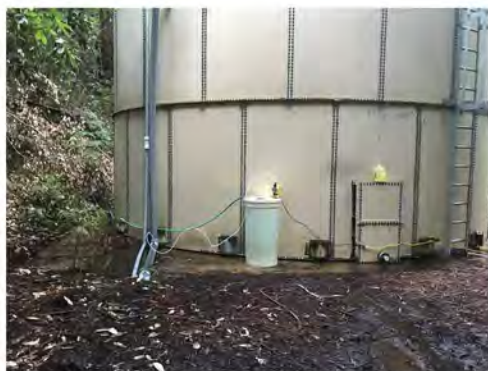
*Figure 1. Temporary Disinfectant Injection Configuration at Well # 4*

Identified Deficiency: Well 4 does not have a 50-foot sanitary seal and continually exerts a chlorine demand on system water that reduces the system chlorine residual. BBWC has been required to install chlorination at Well 4 since the 1994 permit from DDW but has not yet done so. BBWC must provide a plan for wellhead disinfection to DDW no later than March 10, 2019 and provide wellhead disinfection no later than May 20, 2019.

Proposed Corrective Action: In the short term, BBWC has installed a free chlorine injection system to improve the free chlorine residual in the distribution system. The electrical configuration of the chemical pump ensures that the pump only injects chlorine into the tank inlet piping when the groundwater well is operating (see Figure 1).

In the long term, a County permitted chemical storage and injection system will be installed. The system will include a 12.5% sodium hypochlorite solution. The solution will be stored with double containment consisting of a 55-gallon drum inside of a lockable polyethylene housing rated for the outdoors. This PE housing unit will be seated and anchored into a concrete foundation and will be located adjacent to the existing bolted steel tank. A peristaltic pump will inject free chlorine into the well discharge piping through a retractable injection assembly and using chemical piping and tubing to ensure double containment. The chemical pump will be activated whenever the groundwater well pump is running. Grab sampling from the tank outlet piping will confirm disinfectant levels entering the distribution system are adequate. Additional work will be performed to ensure that there is drainage away from the tank base.

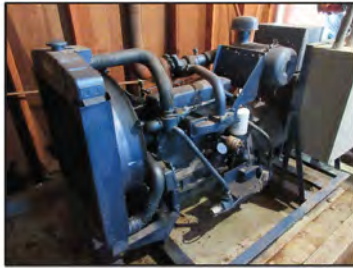
*Figure 9. Generator repaired and operational*

Proposed Corrective Actions: BBWC will replace both ruptured bladders inside the pressure tank with new Amtrol WX-456C bladder tanks. Existing piping and valving will be sandblasted and recoated. The existing generator has already been repaired and is now fully operational (see Figure 9). The existing roof and wood siding will also be replaced to protect the pumping equipment and ensure rodents do not enter the building.

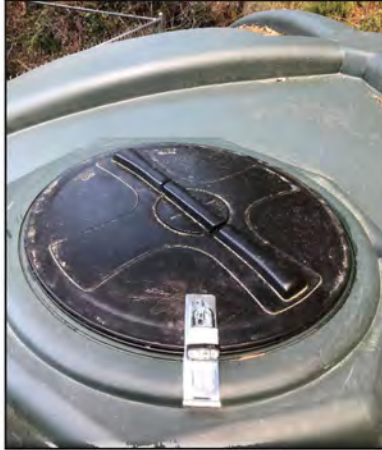
*Figure 10: Roof lock on China Grade Tank.*

Identified Deficiency: The tank site is not secured and DDW recommends a perimeter fence be installed. BBWC must ensure that there are no connections to the previously used redwood tank and install a roof lock.

Proposed Corrective Action: Install 145 feet of 6-ft high chain link fencing surrounding the tank site with one 12-ft entry gate. Construct approximately 1,000 sf of base rock or gravel roadway for safe access to the site. BBWC has installed a roof lock (see Figure 10).

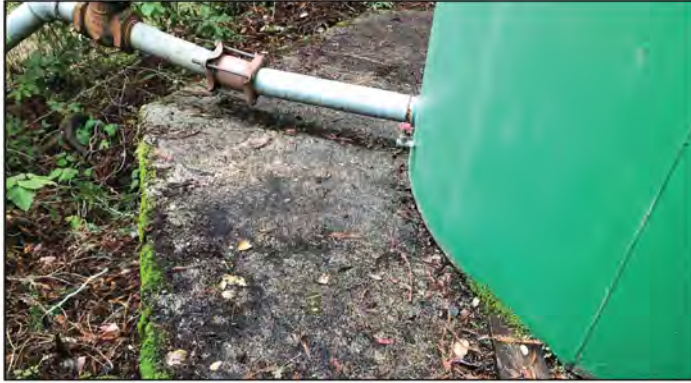
*Figure 12: Oberst Station existing foundation*

Identified Deficiency: The Oberst tank is an aged small steel tank. The interior and exterior coatings are severely corroded. Large rust nodules were observed attached to the interior tank wall. The corrosion presents a sanitary and structural risk. BBWC must provide a plan and schedule for replacement of this tank no later than May 10, 2019. The replacement plan must include NSF 61, AWWA, and Waterworks Standards compliance and a plan to construct a tank foundation and provide proper seismic supports.

Proposed Corrective Action: BBWC will replace the Oberst tank with a 10,000 gallon polyethylene tank anchored to the existing foundation. BBWC will also install a fence surrounding the tank site with a 12-ft swing gate.

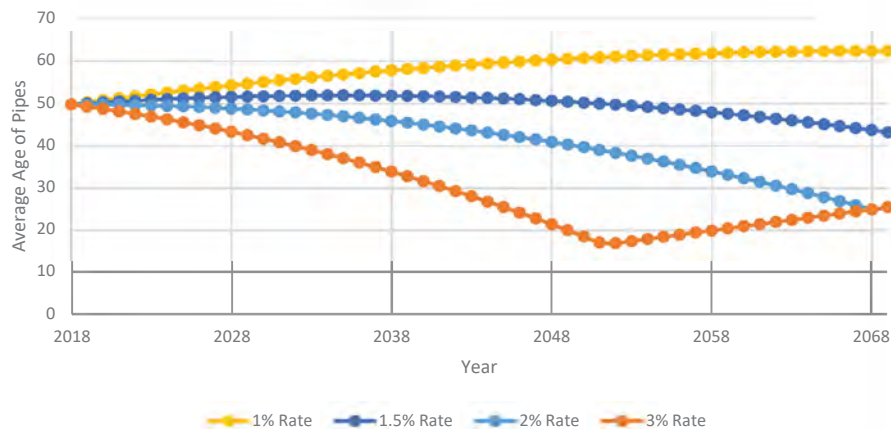
**Figure 14: Average age of pipelines under 1-3% replacement programs**

Proposed Corrective Action: Replace pipelines at a 1.5% rate, or approximately 1,360 ft of pipe per year. An age and failure rate analysis was performed considering the approximate current ages of pipelines in the distribution system and survival curves for existing pipe types. It was assumed that all steel pipelines were installed in the 1940's, all AC pipelines were installed in the 1960's, and all PVC pipelines were installed in the 1990's, and that the oldest pipes with the lowest survival rate are replaced first. The model calculates the average failure rate of all pipelines given their age and the pipe type's survival curve. It assumes that each year a certain percentage

of pipes are replaced, thus reducing the average age and average risk of pipelines across the system. The analysis showed that a replacement rate of 1.5% would ensure that the average age of pipelines in the system does not grow over time, but decreases from about 50 years today to 43 years in 2069 (see Figure 14). Additionally, replacing at a 1.5% rate will prevent the pipeline failure rate from escalating to an unmanageable level. Instead, risk of pipeline failure will steadily decrease over time (see Figure 15).

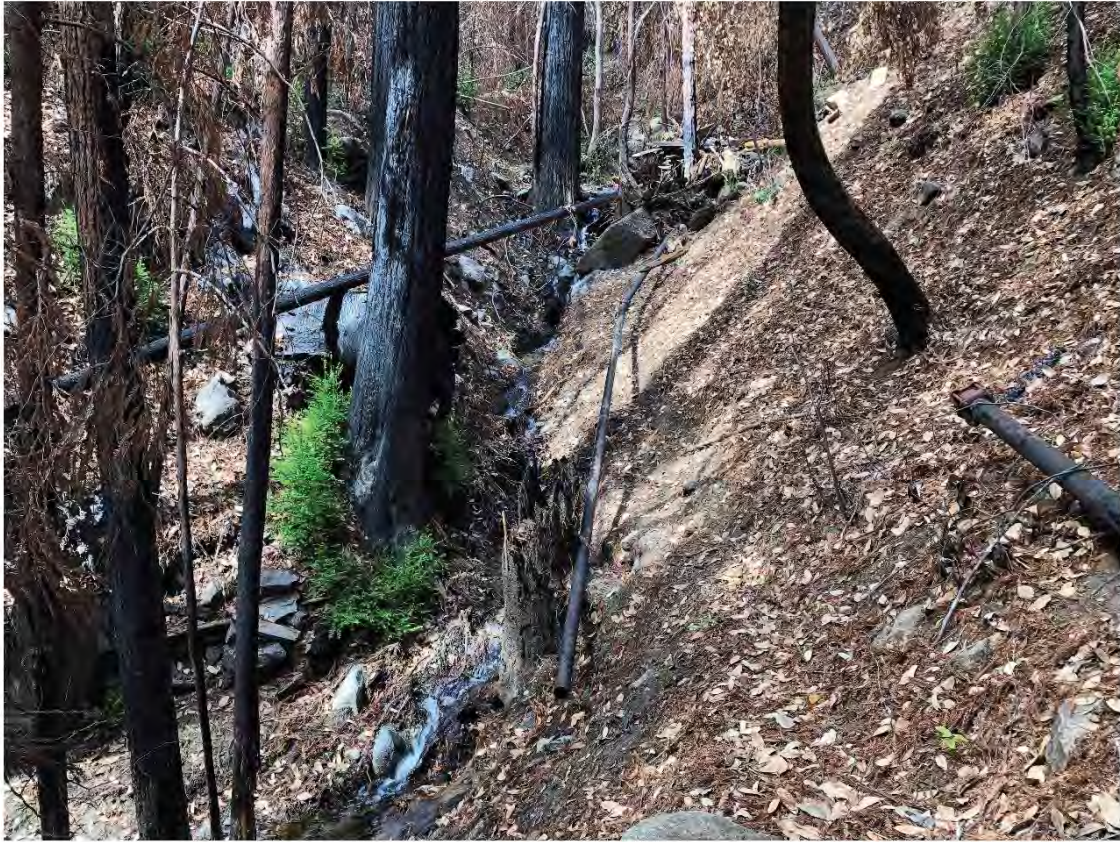
The primary change in the watershed discussed in this WSS update is the 2020 CZU Complex wildland fire that burned extensively through the BBWC service territory and caused extensive damage throughout each of BBWC's primary source watersheds. Notably, the Jamison SWTP was completely destroyed, leaving BBWC with only its groundwater sources available to provide source water capacity, primarily through Well No. 4.

*Typical fire damage in the watersheds.*

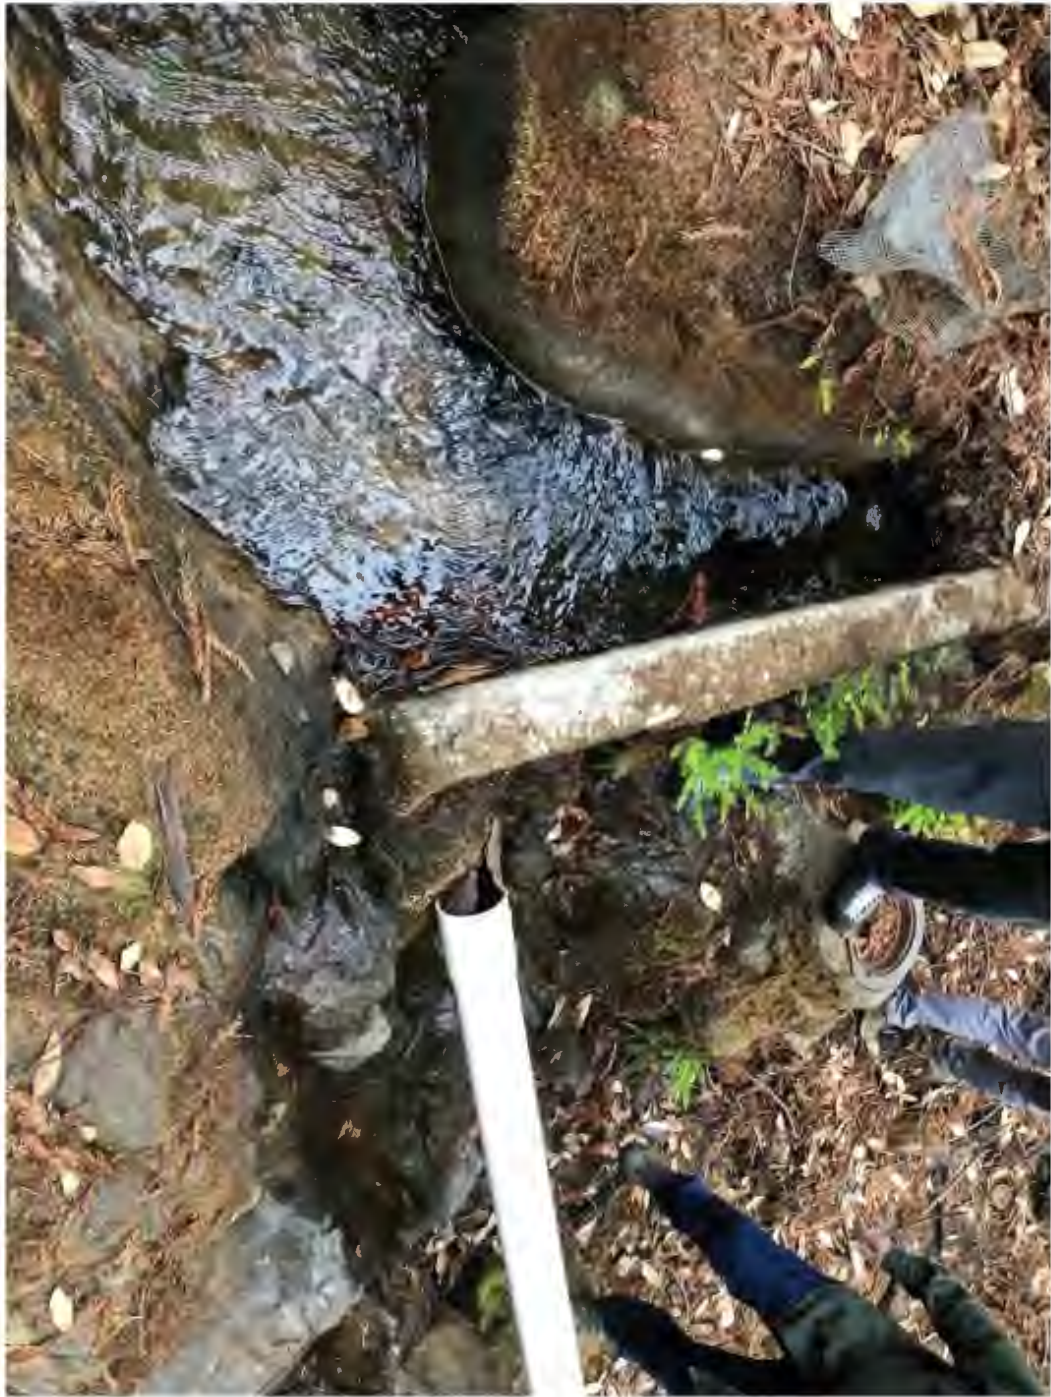
The diversions on Jamison Springs North and South have been repaired following the CZU fire. The diversion consists of a small concrete dam with a four inch steel pipe passing through it. The diversions provide some reduction of large debris and suspended solids from entering the raw water intake pipes. Each pipe has a manually cleaned screen that captures any large solids.

*Repaired South Creek raw water intake*

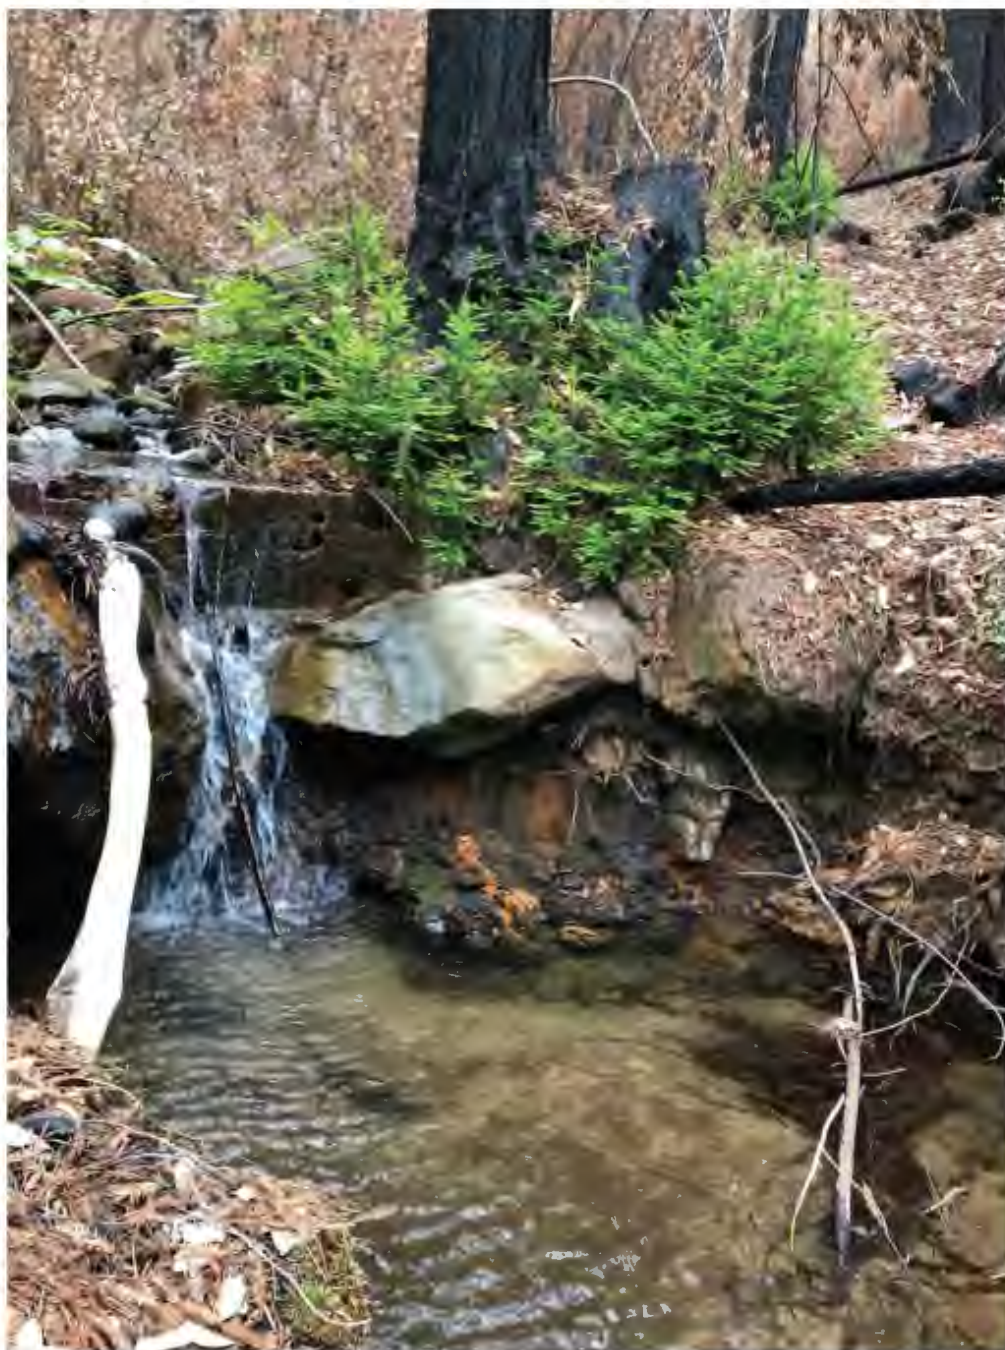
*North Creek intake prior to repairs completed in summer 2021.*

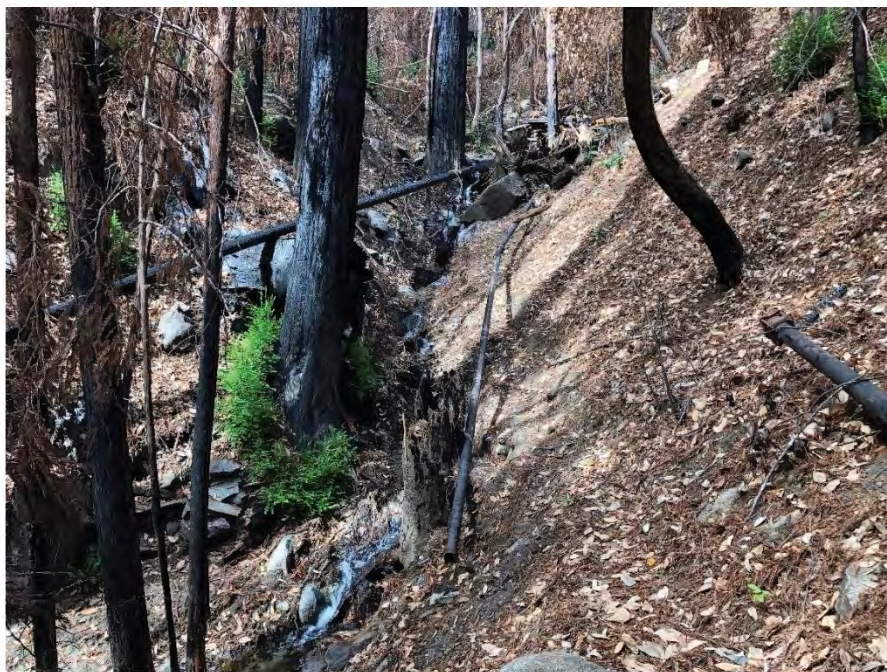
The Corvin Creek intake was completely destroyed by the CZU fire. BBWC plans to rebuild and use the Corvin Creek intake in the future.

*Corvin Creek intake not yet repaired.*

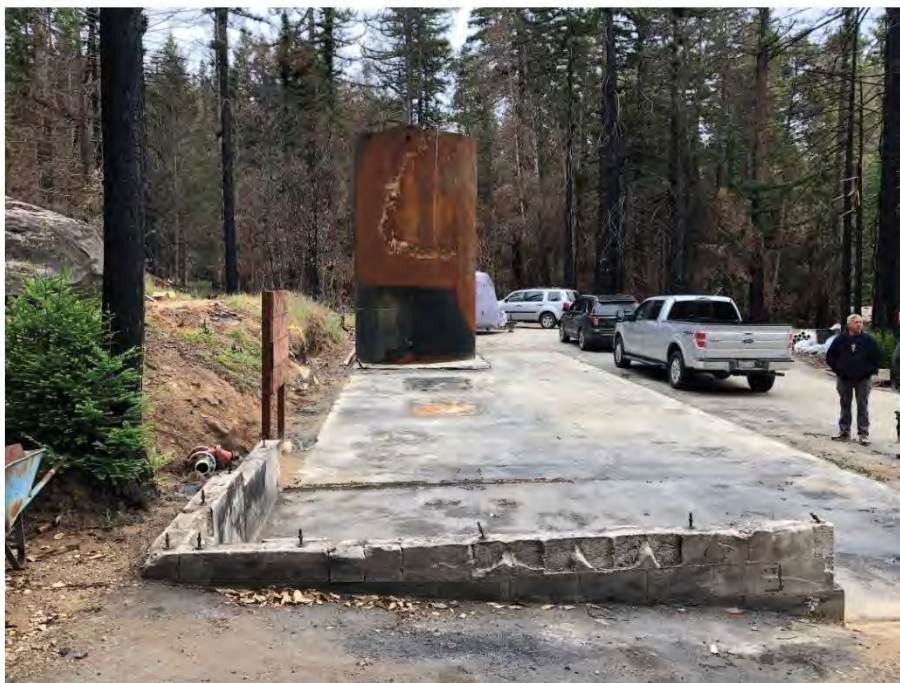
The Jamison Springs SWTP historically received water from Jamison Springs North and South and Corvin Creek. Raw water intakes captured water from both Jamison Springs North and South and conveyed it to a preliminary sedimentation tank. After sedimentation, the water was filtered, and chlorinated prior to storage in the 210,000 gallon storage tank. In 2020, the Jamison Springs SWTP was completely destroyed by the CZU wildfire.

*The remains of the Jamison SWTP after the 2020 CZU wildfire.*

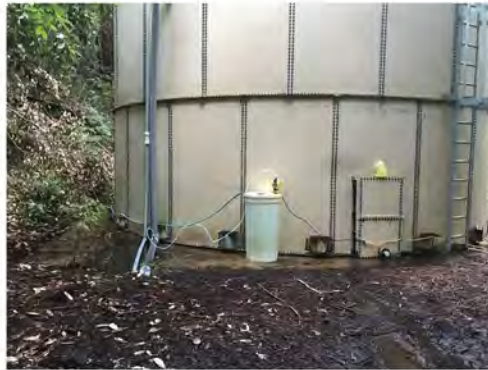
*Figure 1. Temporary Disinfectant Injection Configuration at Well # 4*

Identified Deficiency: Well 4 does not have a 50-foot sanitary seal and continually exerts a chlorine demand on system water that reduces the system chlorine residual. BBWC has been required to install chlorination at Well 4 since the 1994 permit from DDW but has not yet done so. BBWC must provide a plan for wellhead disinfection to DDW no later than March 10, 2019 and provide wellhead disinfection no later than May 20, 2019.

Proposed Corrective Action: In the short term, BBWC has installed a free chlorine injection system to improve the free chlorine residual in the distribution system. The electrical configuration of the chemical pump ensures that the pump only injects chlorine into the tank inlet piping when the groundwater well is operating (see Figure 1).

In the long term, a County permitted chemical storage and injection system will be installed. The system will include a 12.5% sodium hypochlorite solution. The solution will be stored with double containment consisting of a 55-gallon drum inside of a lockable polyethylene housing rated for the outdoors. This PE housing unit will be seated and anchored into a concrete foundation and will be located adjacent to the existing bolted steel tank. A peristaltic pump will inject free chlorine into the well discharge piping through a retractable injection assembly and using chemical piping and tubing to ensure double containment. The chemical pump will be activated whenever the groundwater well pump is running. Grab sampling from the tank outlet piping will confirm disinfectant levels entering the distribution system are adequate. Additional work will be performed to ensure that there is drainage away from the tank base.

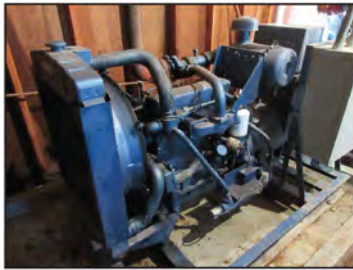
*Figure 9. Generator repaired and operational*

Proposed Corrective Actions: BBWC will replace both ruptured bladders inside the pressure tank with new Amtrol WX-456C bladder tanks. Existing piping and valving will be sandblasted and recoated. The existing generator has already been repaired and is now fully operational (see Figure 9). The existing roof and wood siding will also be replaced to protect the pumping equipment and ensure rodents do not enter the building.

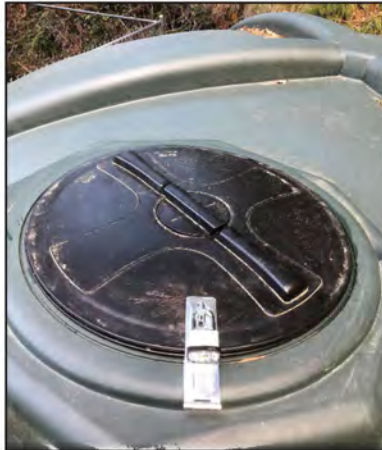
*Figure 10: Roof lock on China Grade Tank.*

Identified Deficiency: The tank site is not secured and DDW recommends a perimeter fence be installed. BBWC must ensure that there are no connections to the previously used redwood tank and install a roof lock.

Proposed Corrective Action: Install 145 feet of 6-ft high chain link fencing surrounding the tank site with one 12-ft entry gate. Construct approximately 1,000 sf of base rock or gravel roadway for safe access to the site. BBWC has installed a roof lock (see Figure 10).

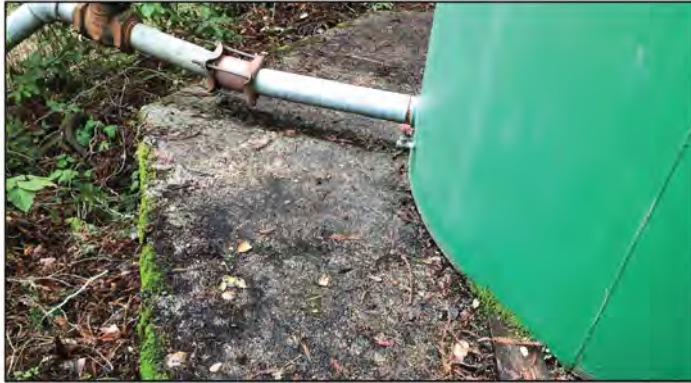
*Figure 12: Oberst Station existing foundation*

Identified Deficiency: The Oberst tank is an aged small steel tank. The interior and exterior coatings are severely corroded. Large rust nodules were observed attached to the interior tank wall. The corrosion presents a sanitary and structural risk. BBWC must provide a plan and schedule for replacement of this tank no later than May 10, 2019. The replacement plan must include NSF 61, AWWA, and Waterworks Standards compliance and a plan to construct a tank foundation and provide proper seismic supports.

Proposed Corrective Action: BBWC will replace the Oberst tank with a 10,000 gallon polyethylene tank anchored to the existing foundation. BBWC will also install a fence surrounding the tank site with a 12-ft swing gate.

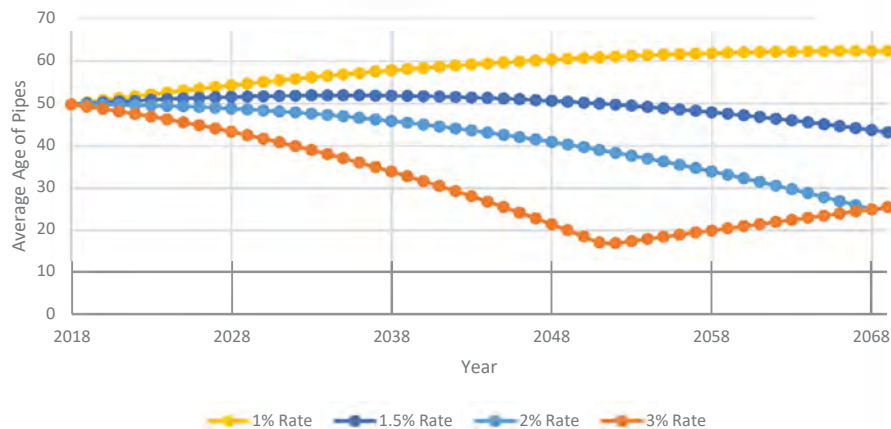
**Figure 14: Average age of pipelines under 1-3% replacement programs**

Proposed Corrective Action: Replace pipelines at a 1.5% rate, or approximately 1,360 ft of pipe per year. An age and failure rate analysis was performed considering the approximate current ages of pipelines in the distribution system and survival curves for existing pipe types. It was assumed that all steel pipelines were installed in the 1940's, all AC pipelines were installed in the 1960's, and all PVC pipelines were installed in the 1990's, and that the oldest pipes with the lowest survival rate are replaced first. The model calculates the average failure rate of all pipelines given their age and the pipe type's survival curve. It assumes that each year a certain percentage

of pipes are replaced, thus reducing the average age and average risk of pipelines across the system. The analysis showed that a replacement rate of 1.5% would ensure that the average age of pipelines in the system does not grow over time, but decreases from about 50 years today to 43 years in 2069 (see Figure 14). Additionally, replacing at a 1.5% rate will prevent the pipeline failure rate from escalating to an unmanageable level. Instead, risk of pipeline failure will steadily decrease over time (see Figure 15).

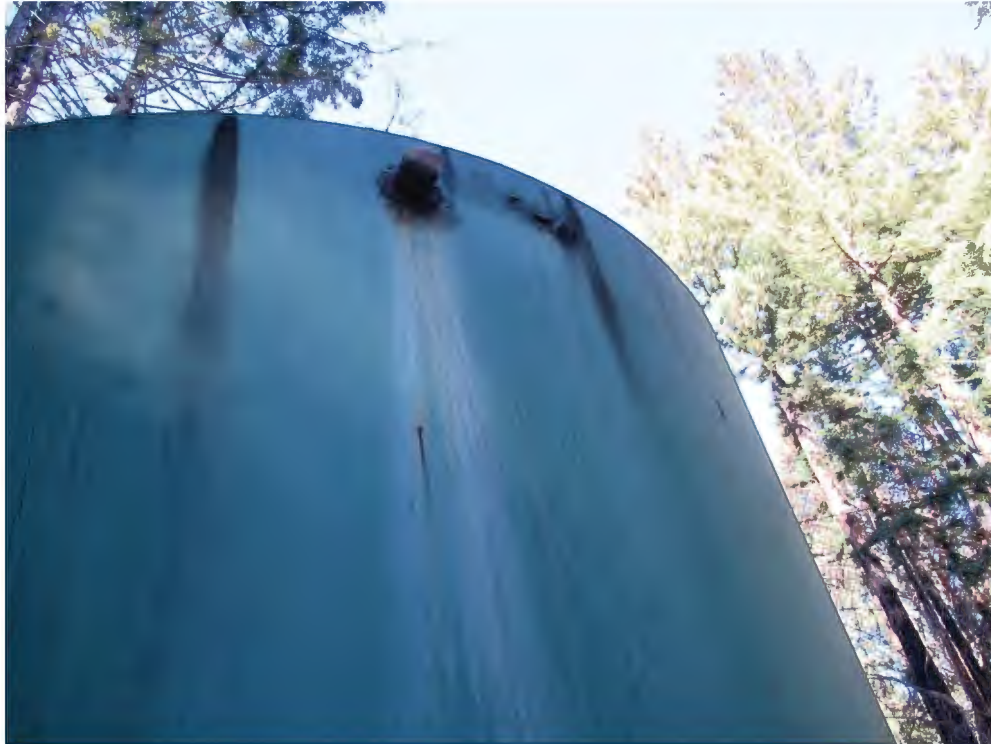
Holes in the Tank Sidewall

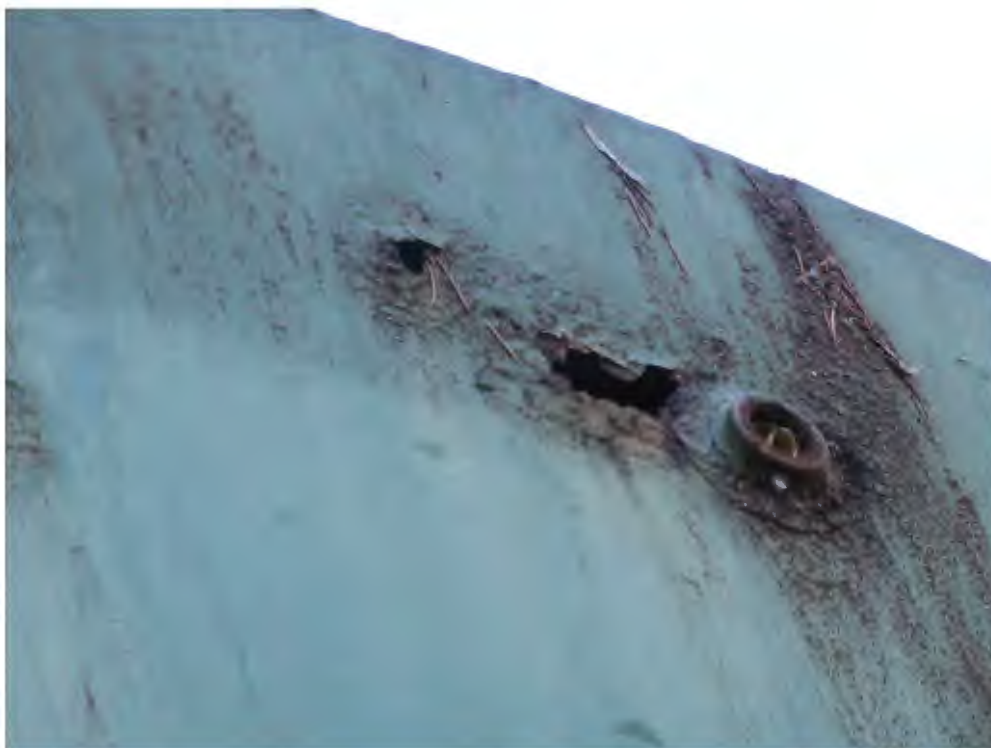
Enlarged Image of Tank Sidewall Holes

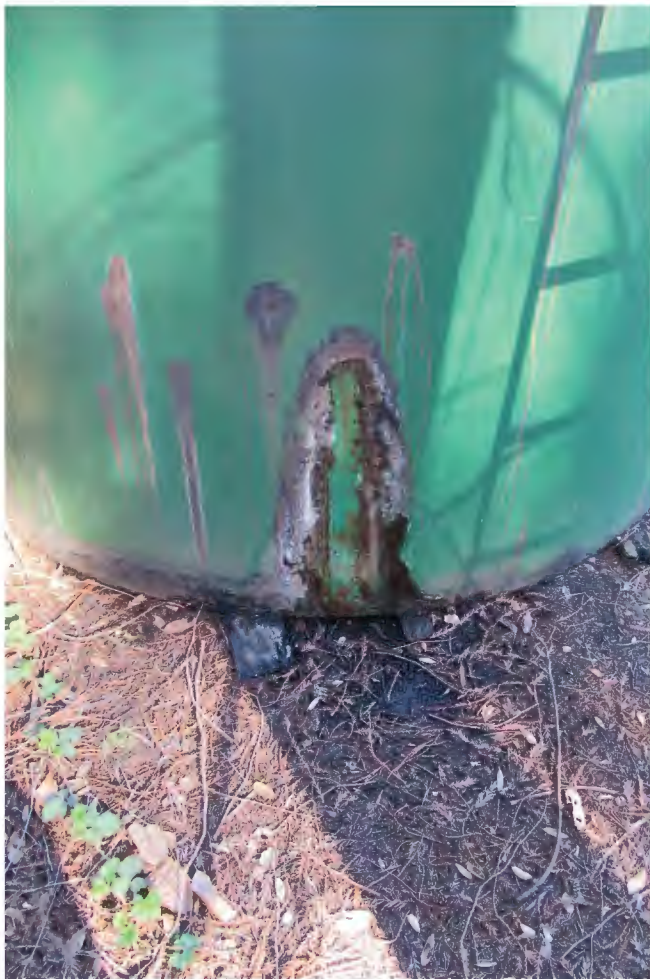
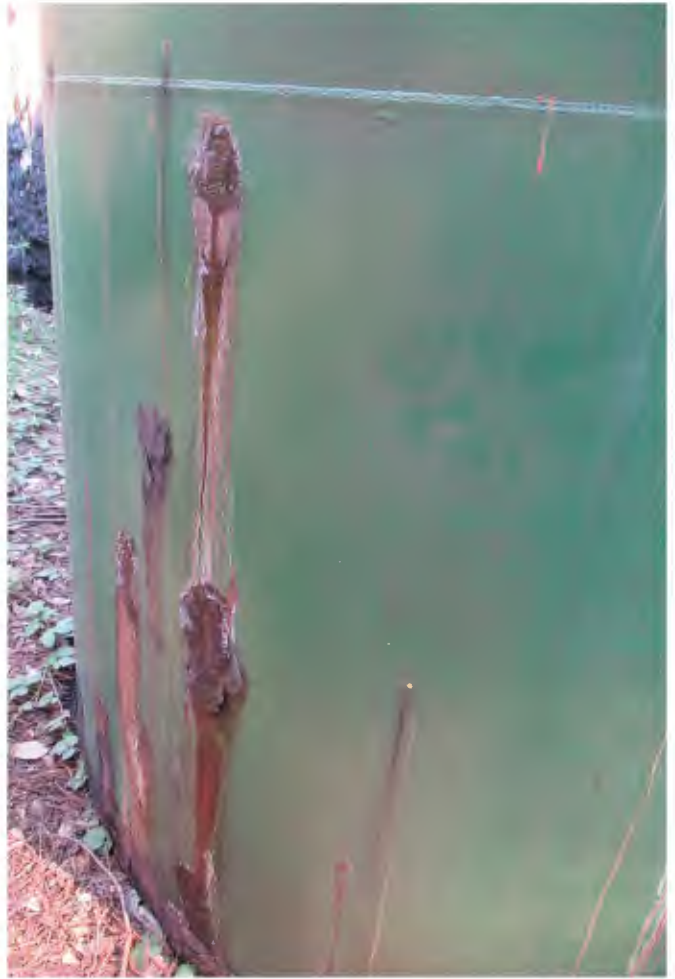
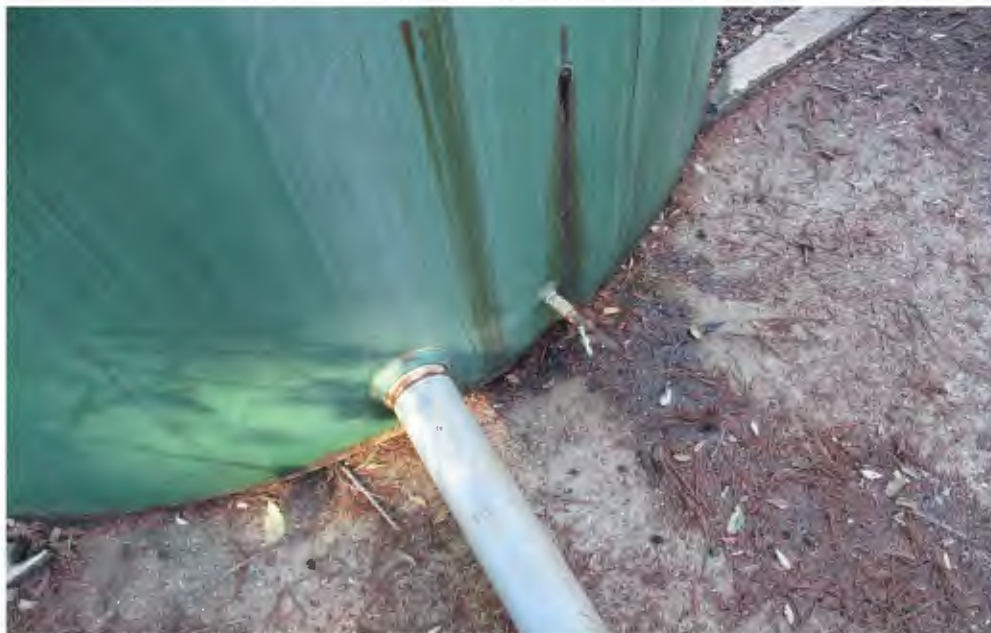
Corrosion and Leaks in the Tank Sidewall
